DIVINE INTERVENTION
THE RESTORATION OF THE
DIVINE LORRAINE HOTEL

DIVINE INTERVENTION

THE RESTORATION OF THE DIVINE LORRAINE HOTEL IN PHILADELPHIA IS BRINGING THE BUILDING BACK TO ITS ORIGINAL GLORY.

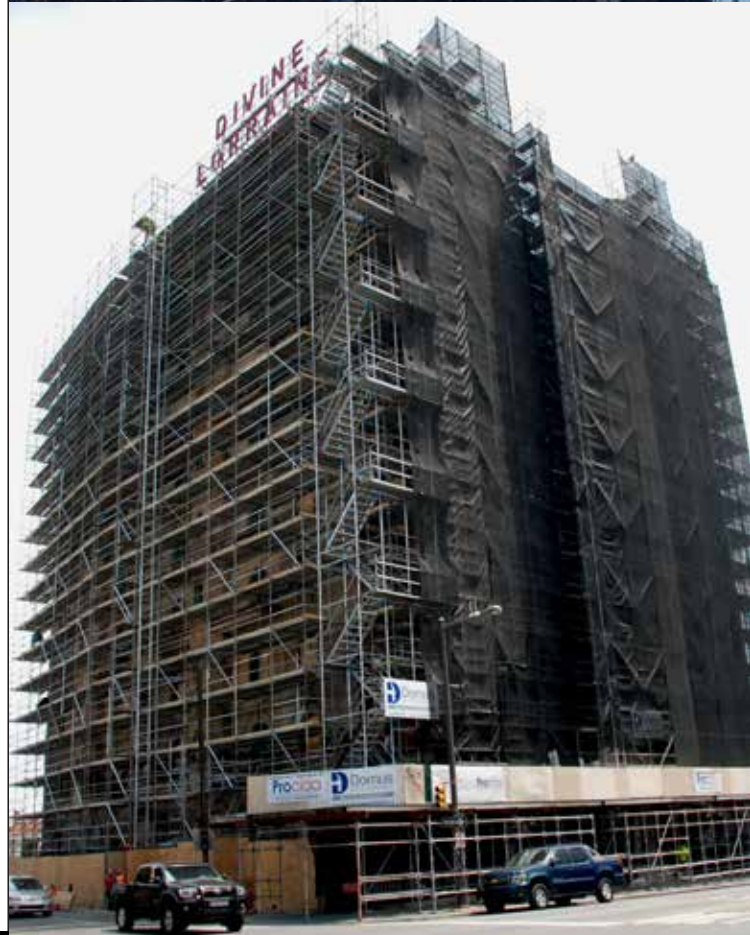
The west side went up first and included approximately 120 linear feet of system scaffold. The scaffold was roughly 128-feet high by 120-feet long and ran the entire length of the building on Broad Street. It had a work deck for crews every 6.5 feet and a Beta Max Maxial Track hoist to lift equipment. The scaffolding was completely covered in debris netting.

The scaffold provided restoration crews complete access to the exterior for renovations, repointing, surface cleaning, parapet and soffit work, brick replacement, balcony repair, and window painting and replacement. The scope was essentially the same on each of the sides.

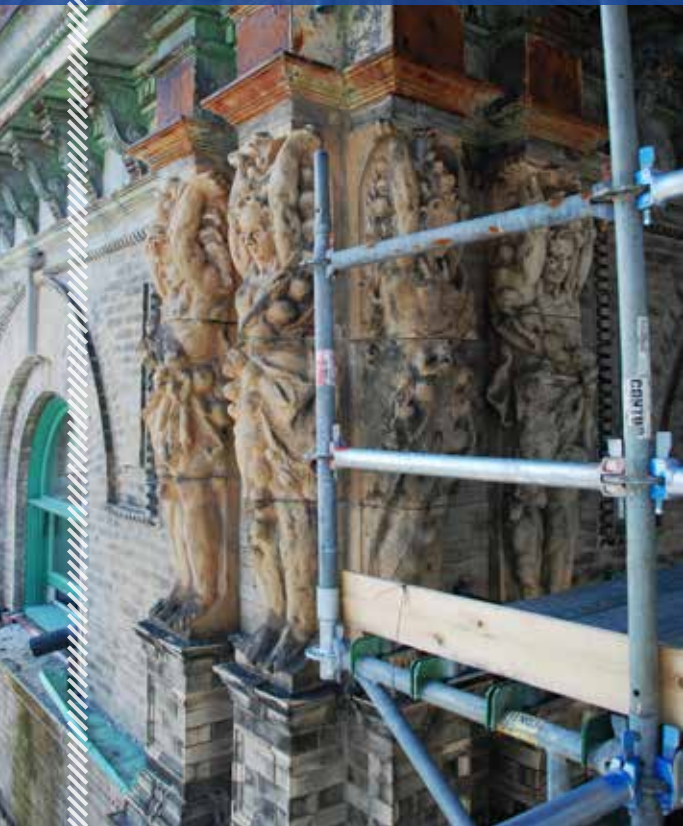
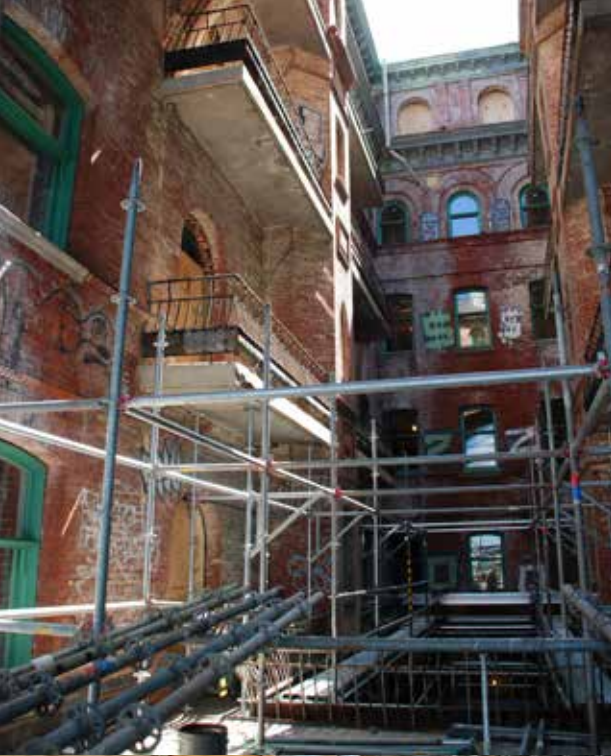
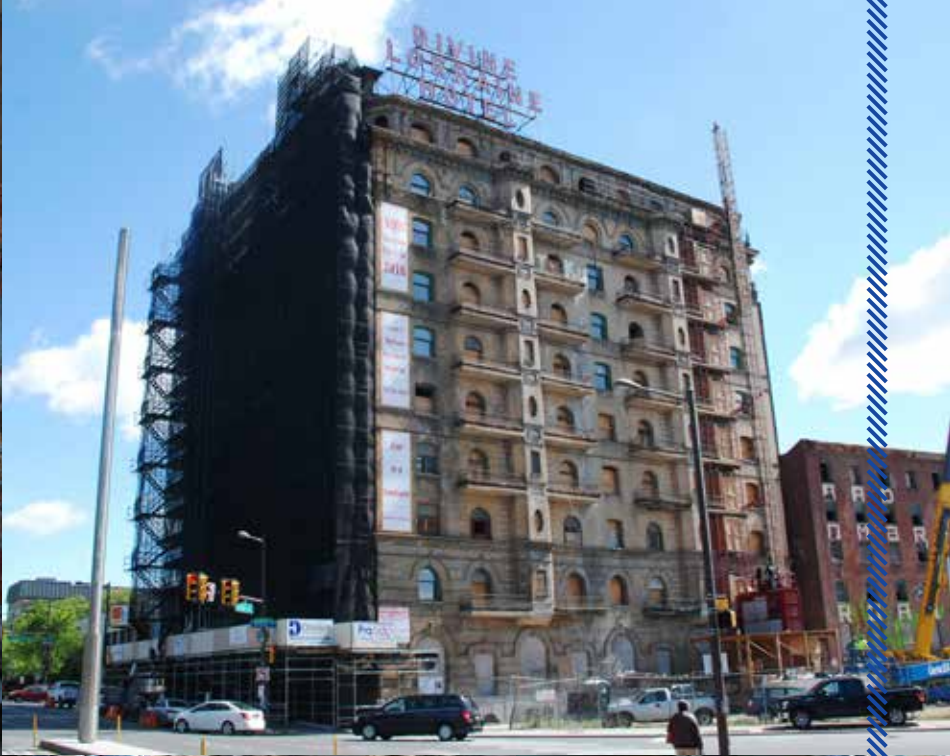
The courtyard was roughly 90-feet long by 80-feet high. The scaffold could not be set on the second-story roof area, because it was really a false skylight. The gap was bridged with 21-foot aluminum beams that set on the window sills, and the scaffold was erected on top of that. The large aluminum beams had to come out of windows every third floor to support the weight of the scaffold.

Some of the other challenges presented by the courtyard included loading materials into the courtyard area, up and over the canopy, and building the scaffold and stepping back into the balconies in the courtyard. The resulting structure was very stable and allowed renovation crews safe access to the building.
